The Complaint of TUG HELEN B. MORAN, INC., as owner,
and MORAN TOWING & TRANSPORTATION Co., INC., as
chartered owner, of the Tug DIANA L. MORAN for ex-
oneration from or limitation of liability,

JOINT EXHIBIT VOLUME

Halboth Survey Report

Subject: TOMLINSON BRIDGE
Struck by Barge "BECRAFT" in tow of
Tugs "DIANA L. MORAN" and "DEVON"
May 17, 1972

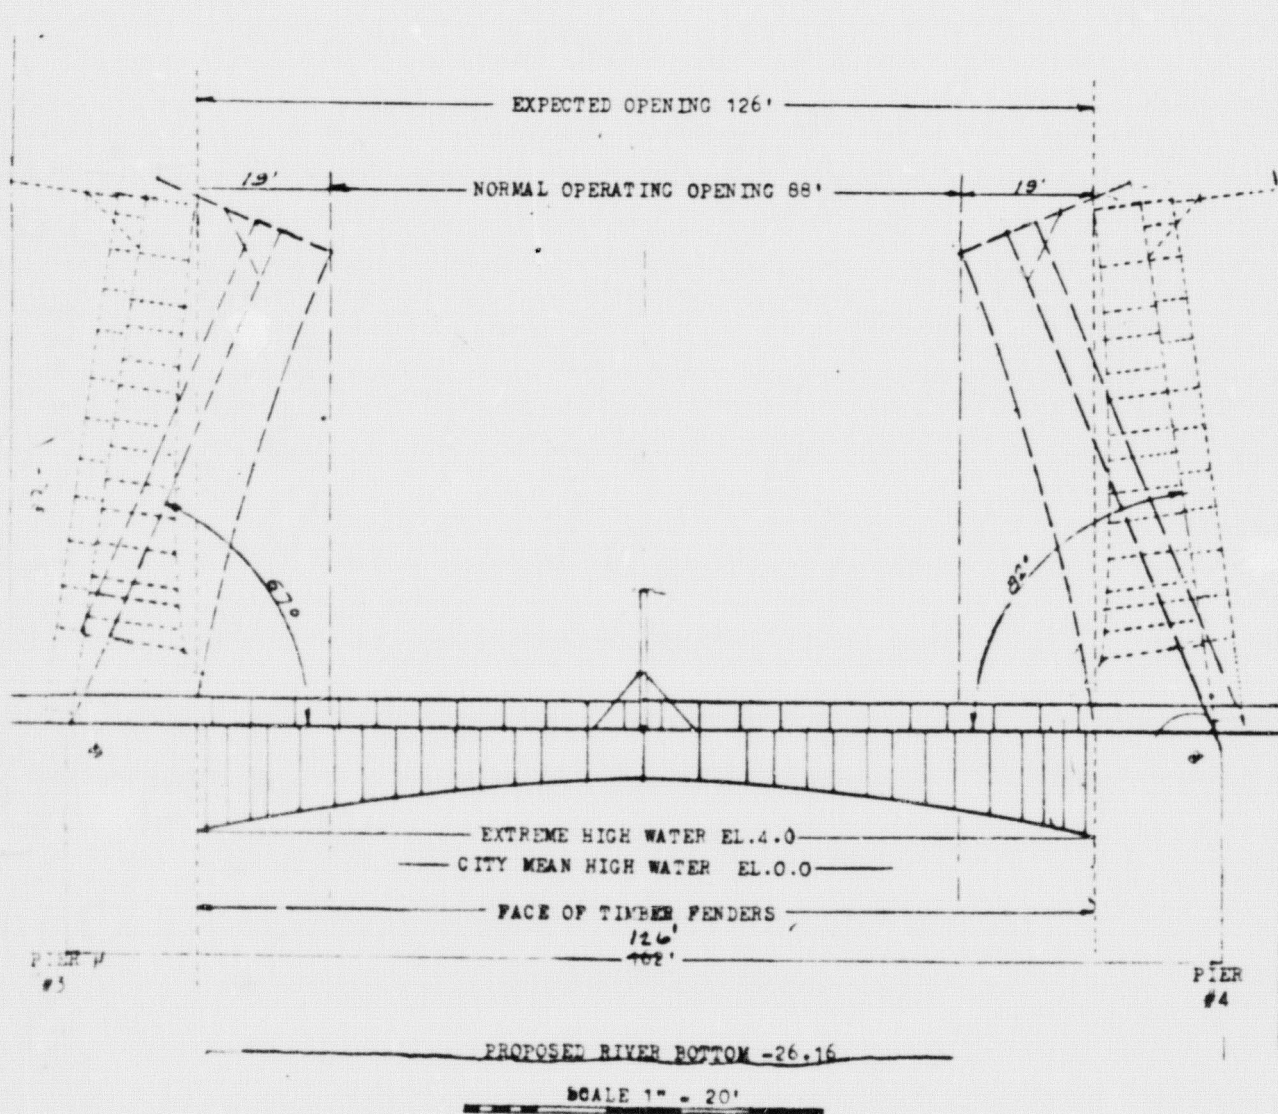
Exhibit 35A

SKETCH DRAWN FROM DIMENSIONS SHOWN AND SCALED FROM
COPY OF PLANS FOR TOMLINSON BRIDGE APPROVED BY THE
CHIEF OF ENGINEERS AND THE ASSISTANT SECRETARY OF
WAR ON 26 JUNE 1922, WHICH SPECIFIED AN EXPECTED
HORIZONTAL OPENING OF 126' AT THE TOP OF THE RAISED
BASCULE LEAVES WHICH IS ACCOMPLISHED BY ELEVATING
THE LEAVES TO 82'.

WITH THE LEAVES RESTRICTED BY LIMIT SWITCHES TO 67
THEY PROVIDE UNLIMITED VERTICAL CLEARANCE FOR ONLY
THE CENTER 88' (SCALED) OF THE DRAW INSTEAD OF THE
126' AS APPROVED.

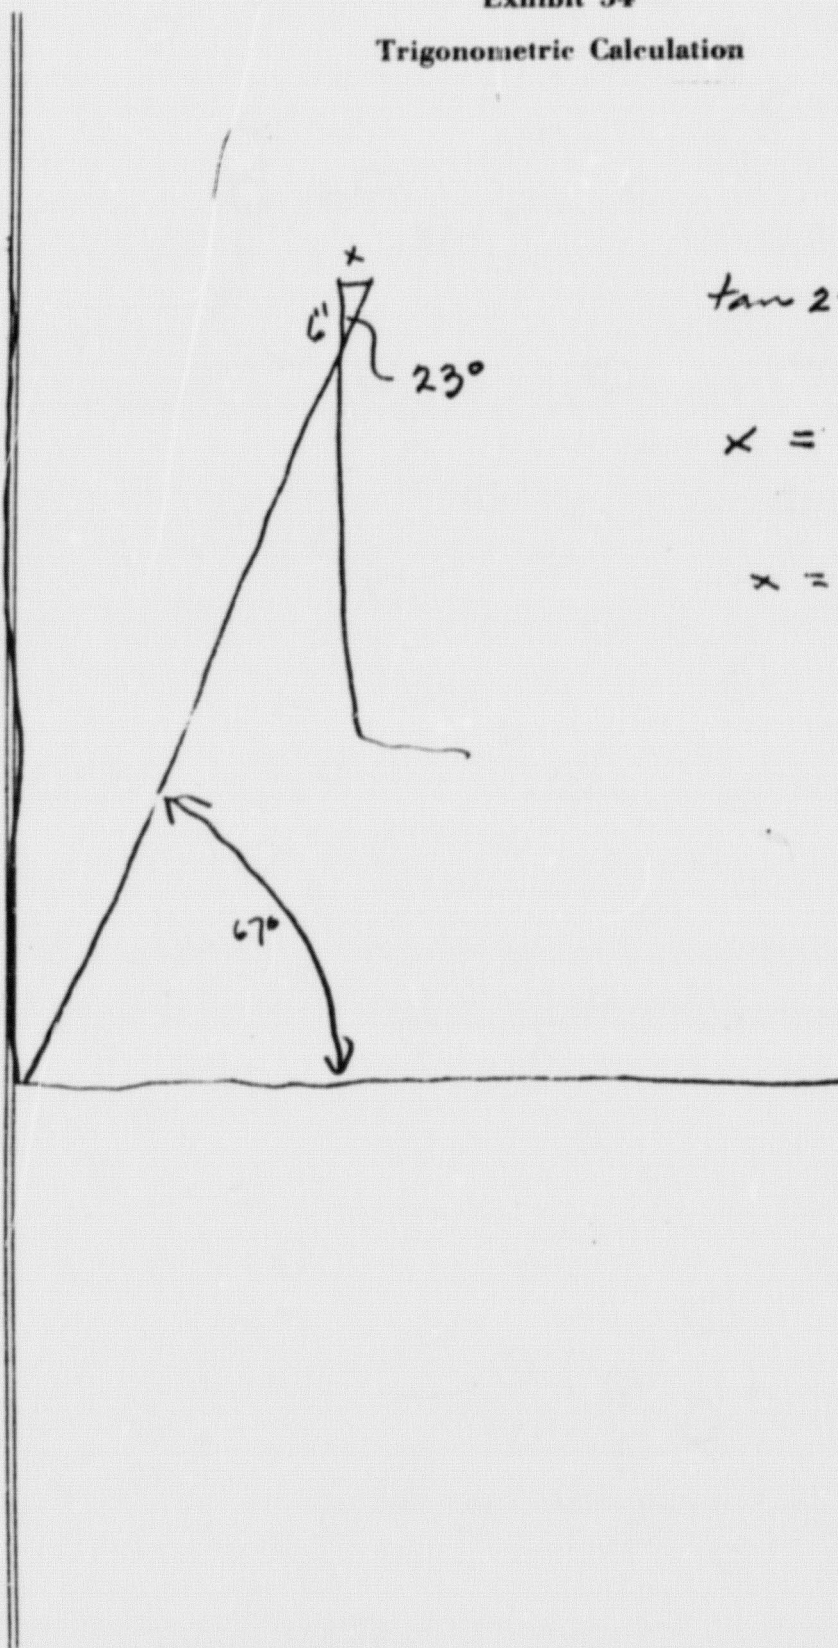
Exhibit 54

Trigonometric Calculation

$$\tan 23 = \frac{x}{6}$$

$$x = 6 \times \tan 23^\circ$$

$$6 \times .424$$

$$x = 2.544$$
